# CAVITATION EROSION OF WET-SLEEVE LINERS: CASE STUDY

## ABSTRACT

The aim of this paper is to present the cavitation erosion mechanism through three practical examples. The first one concerns heavily damaged by cavitation erosion on diesel engine in the cooling system of which, no cooling conditioners had been used. The second one presents several cases of cavitation damage on cylinder liners that had been protected by different anticorrosion inhibitors. The last example is a diesel engine the cooling system of which is not properly maintained.

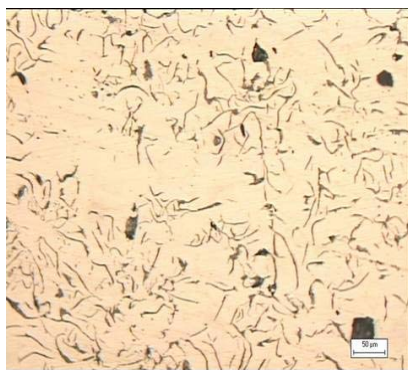
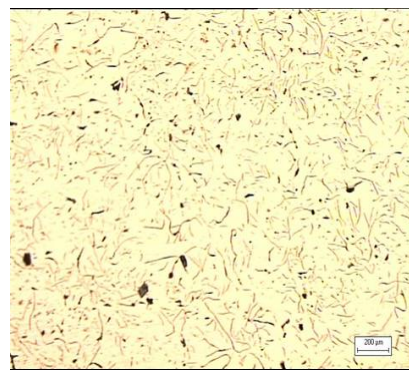
Table 1 summarizes chemical compositions and mechanical properties of the wet-sleeve liners, which were used in the examinations reported here. By metallographical analysis, it is resulted that liners "type A" appear more quality microstructure. Figure 1 shows the metal microstructure of liners "type A" and "type B".

**Figure 1:** a) Metal microstructure of liners "type A", and b) Metal microstructure of liners "type B".

It is clear that the most significant variable in cavitation erosion is the vibration of the cylinder liners and thus this problem is addressed in the design of the engines. The liners with different hardening and mechanical properties exhibit varying degrees of cavitation erosion. The liners "type A" appeared high percentage of cavitation erosion in comparison with the others. In order to solve the cavitation phenomenon in liners "type A", it was decided to test a new type wet-sleeve liner. For this reason, a new liner "type A" with greater wall thickness was manufactured. According to the results in Figure 2, the cavitation erosion phenomenon after the year 1999 was limited. Today, the rebuilt engines operate up to 6000 working hours and all new liners "type A" were not attacked by cavitation erosion.

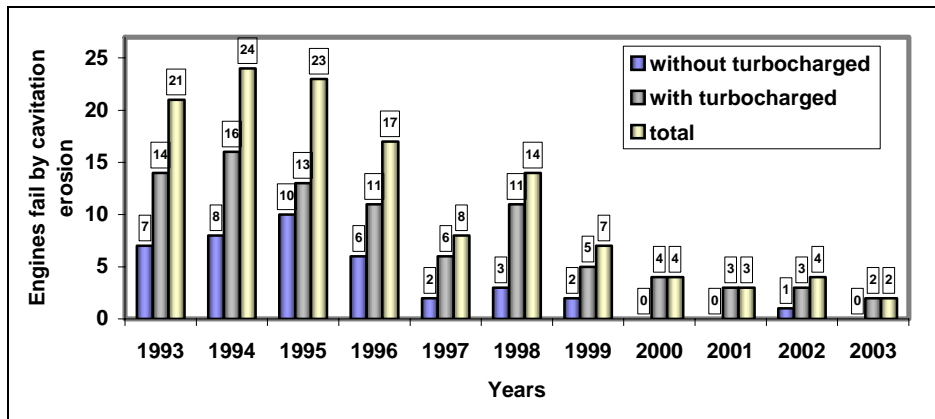
The cavitation phenomenon was observed only into liners "type A". Particularly, in 502 diesel engines, with liners "type A", cavitation erosion was observed into 127 cases, that is 25,3%. Figure 2 presents the cavitation phenomenon evolution on 127 failed engines with or without turbocharged.

**Figure 2:** Evolution of the cavitation phenomenon on the 127 failed engines with or without turbocharged.

It was observed also, that the expansion of the cylinder wall is clearer as the demand for power is increasing. The engines, which have a turbocharged unit, are increasing air charge and are pumping more fuel into the cylinder. This increase in fuel and air causes a more violent ignition, which increases further cylinder pressures and thus increases the flexing of the cylinder liner wall. The liners of these engines were completely damaged by cavitation erosion in short time. According to the above-mentioned results (Figure 2), 69,3% of the total failed engines by cavitation phenomenon, were equipped with turbocharged.

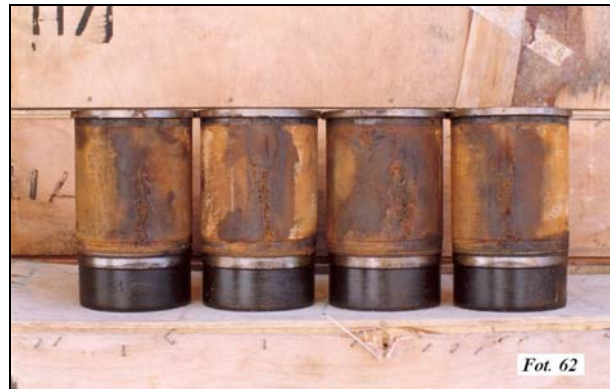
Corrosion and cavitation wear in wet-sleeve liners is shown in Figure 3. This approach was tested on four-cycle diesel engines, with 4 cylinders of bore x stroke = 105 x 115,5 mm, in the cooling system of which distilled water had been used. Figure 3 shows the liners after 1000 working hours subjected to the vibratory cavitation environment of diesel engine. The wear is evident and in advanced stage to all the cylinder liners. The corrosion erosion had little effect on forming the honeycombed structure of the eroded surface. Corrosion appears on the liner wall due to electrochemical action and causes damage but the rate normally decreases as an oxide layer is formed. When cavitation erosion also occurs, the protective oxide layer is removed by bubble collapse. The deeply pitted appearance of the eroded surface is characteristic of the cavitation erosion. The location of the pits is coming from the bottom to the middle of the liners on the thrust side. In the antithrust side of the liners cavitation eroded surface is not formed.

**Figure 3:** Corrosion and cavitation erosion in wet-sleeve liners was observed after 1000 working hours. It is about a turbocharged engine with 4 cylinders of bore x stroke = 105 x 115,5 mm, in the cooling system of which anticorrosion and anticavitation inhibitors had not been used.

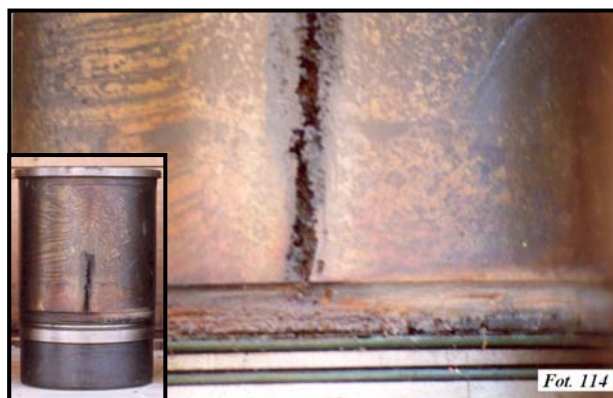
In order to reduce wet-sleeve liners erosion, different anticorrosion and anticavitation inhibitors were used in the coolant as an inexpensive and easy to use method. The inhibitors had been used according to the producers' advice. This approach was tested on four-cycle diesel engines with 4 and 6 cylinders of bore x stroke = 105 x 115,5 mm. However, after 800÷1500 h of operation, wear was still found on the liners. Figure 4 shows a liner, which was totally protected from corrosion erosion but on the liner wall uniform removal of further material layers was appeared due to cavitation erosion. The turbulence agitation caused by the cavitation in the liquid decreases the diffusion boundary near the metal surface and it probably incorporates dissolved oxygen into the cavities. These factors tend to increase the passivation of the metal. When the bubbles collapse, they create a very small, high velocity water jet, which, according to the photo below, is applied to a very small area

of the liner surface and results to high stress. Cavitation exposure causes deformation of the grey cast iron and cracking of passive film due to mechanical impact forces of the cavity collapse exposing fresh surface at the liners wall. In this case cavitation erosion causes a pitted honeycombed surface and completely penetrates the liner wall, perforations go all the way through to the combustion chamber, resulting to the mixing of cooling liquid with lubricating oil.

**Figure 4:** Cavitation erosion with removal of further material layers in wet-sleeve liners was observed after 1500 working hours. It is about a turbocharged engine with 6 cylinders of bore x stroke = 105 x 115,5 mm, in the cooling system of which anticorrosion and anticavitation inhibitors had been used.

A variety of strategies had been used to control cavitation erosion on wet-sleeve liners. Cooling additives that incorporate anticorrosion and anticavitation inhibitors were used to reduce the cavitation process to an acceptable rate. From the above, it appears that the proper cooling system maintenance using the right antifreeze and keeping up proper levels of recommended additives is essential to keep the surface corrosion under control, but it can't be a major force in preventing liners pitting. The aspects of "a good radiator pressure cap help keeping ambient pressures above the vapour pressure of the coolant, thereby, reducing the amount of cavitation" or "the thermostat keeps the temperature of the coolant at a level that reduces the energy level of the bubble collapse" they were not confirmed by our experiments in the field conditions.

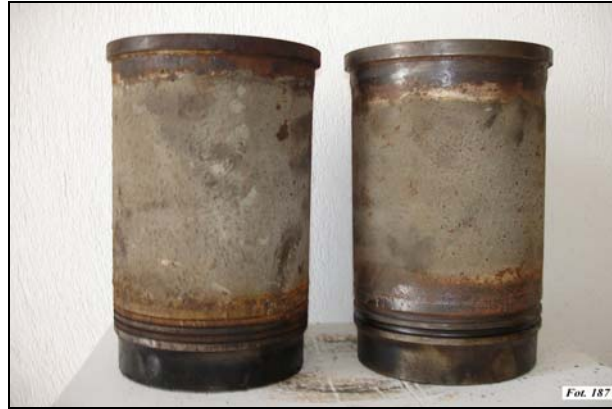
Construction changes such as thickening the liner wall and coatings seem the only effective way in reducing cavitation erosion. Figure 5 shows wet-sleeve liners that were not damaged by cavitation erosion after 5600 h operation. This approach was tested on four-cycle diesel engines with 4 and 6 cylinders of bore x stroke = 110 x 120 mm. The thickness of the liner wall is 8,3 mm versus 5,3 mm of the above mentioned cases. The cooling system of this diesel engine was not properly maintained. Muddy deposit appears on the liners wall.

**Figure 5:** Wet-sleeve liners were not damaged by cavitation erosion after 5600 h operation. This approach was tested on a turbocharged engine with 6 cylinders of bore x stroke = 110 x 120 mm. The thickness of the liner wall was 8,3 mm, and the cooling system is not properly maintained.
